# MARYLAND HISTORICAL TRUST DETERMINATION OF ELIGIBILITY FORM

Property Name:	CASTLE HEIRS HOU	JSE		Inventory/N	lumber:	F-1-009	-
Address:	3702 Commerce Street	City:	Point of Rocks				
County:	Frederick	USGS T	opographic Map:	Point of Rocks, ( 280884E 435013		Quadrangle	
Owner:	Mr. Vernon P. Shores		Is	the property being	evaluated	a district?	yes
Tax Parcel Number:	83 Tax Map Number	108A	Γax Account ID N	Number:004484			
Project: R	Repetitive Flood Claims clea	rance projec	etAger	cy: Federal Emerg	ency Mana	agement Ager	ncy
Site visit by MHT Sta	nff:noX_ye	s Name	: unknown	D	ate: 197	78	
Is the property located	d within a historic district?	yes	X_no				
If the property is with	hin a district		District In	ventory Number:			
NR-listed district	yes Eligible district	yes	District Na	ne:			
Preparer's Recommo	endation: Contributing re	sourcey	resno Non	-contributing but e	ligible in a	nother conte	ct
If the property is not	within a district (or the pro	nerty is a di	strict)

Continuation Sheet No. 1 = -/-9

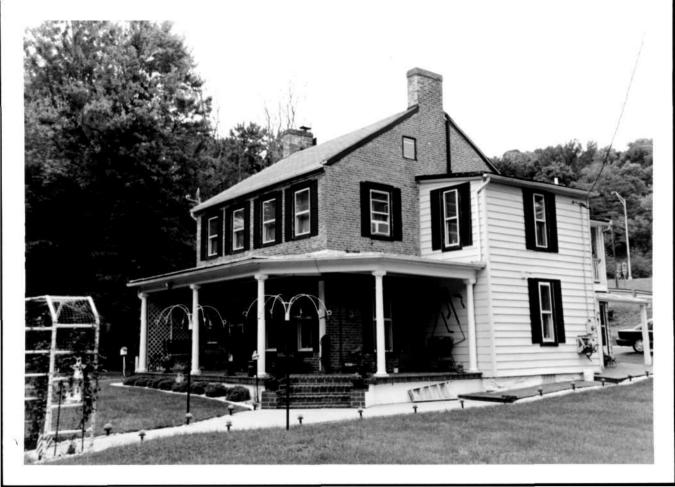
12 MIHP # F-1-009 F CASTLE HEIRS HOUSE I FREDERICK, MP A Phillip W. Newbergs Photographer Thotograph Taken: 13 September 2006 A Location of Negative: NO SHPO # Oblique View of Southeast Corner (Looking Northwest)

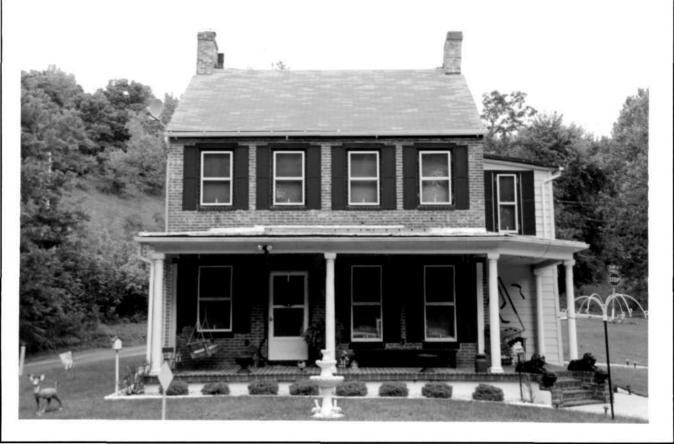
The simplicity of the original 4 bay wide by 2 bay deep, gable roofed, two and one half story brick structure is evident when viewing the front façade and when looking at the southwest corner. Despite the additions of a one story porch that stretches across the front of the lower level, the builder's interpretation of a vaguely federal style aesthetic is still visible in the overall simplicity of geometric form and the strict regularity and alignment of masonry openings. Compromising the purity of this form are the additions to the east and north which not original to the construction, appear to be historic. Even though these additions are visually compromised by the addition new siding, windows and roofing materials, they clearly read as additions to the original masonry building form. Inside the house, alterations to wall surface treatments and moldings make it difficult to determine to what extent the original plan has been retained. Yet, despite many changes, the overall integrity of the design has been retained.

9 MIHP # F-1-009 O CASTLE HEIRS HOUSE O FREDERICK COUNTY, MD a Phillip W. Neaberg, Photographer I Photo Taken: 13 September 2006 P Location of Negative: MD SHPO a South (front) Facade

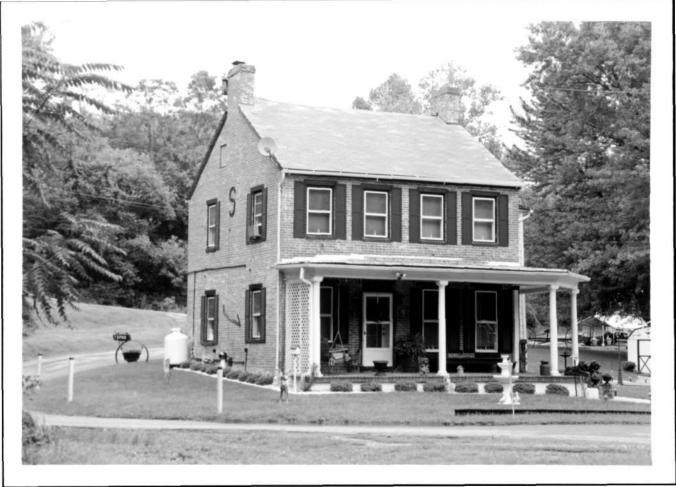
PM 1HP # F-1-009 # CASTLE HEIRS HOUSE F FREDERICK COUNTY NID a Philip W. NEUBERGO Phetographer # Photograph Takon: 13 September 2006 Abocation of Negotive: MD SHOO HOBlique View of Southwest Corner Clooking northeast)

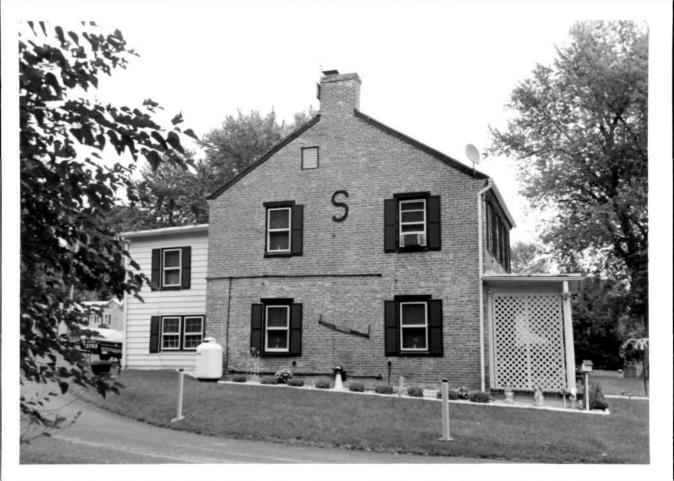
FMIHP # F-1-009 PLASTLE HEIKS HOUSE A FREDERICK COUNTY, MP I Phillip W. Neuberg, Photographer Photo Taken: 13 September 2006 A Location of Negativo: MO 5/4PO 4 West Elevation

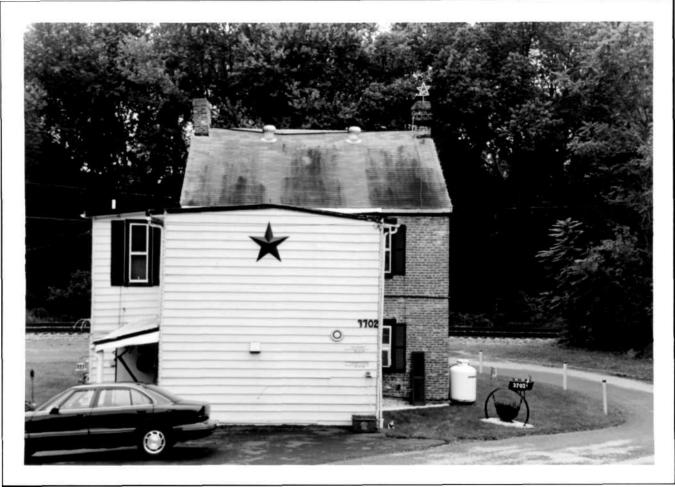
# MIHP # F-1-009 I CASTLE HEIRS HOUSE A FREDERICK COUNTY, SID 4 Phillip W. Newberg, Photographer # thato Taken: 13 September 2006 4 Location of Negative: MD SHPO A North Elevation

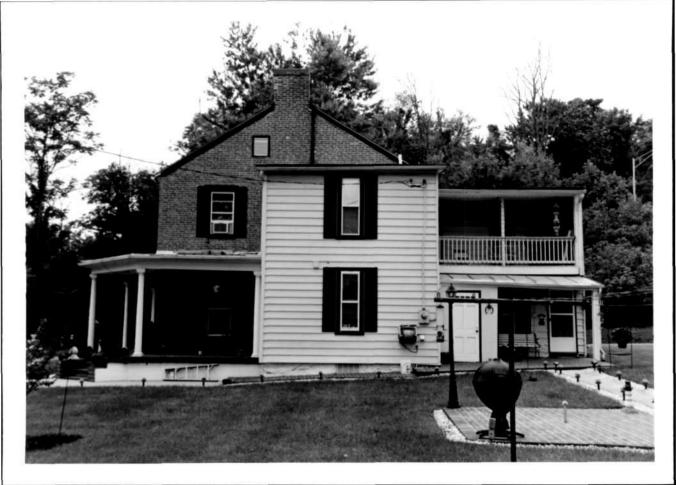
A MIHP # F-1-009 A CASTLE HEIRS HOUSE # FREDERICK COUNTY, MID # Phillip W. New beg, Photographer I Photo Taken: 13 September 2006 Flocation of Negative: 10 FEAST ELEVATION

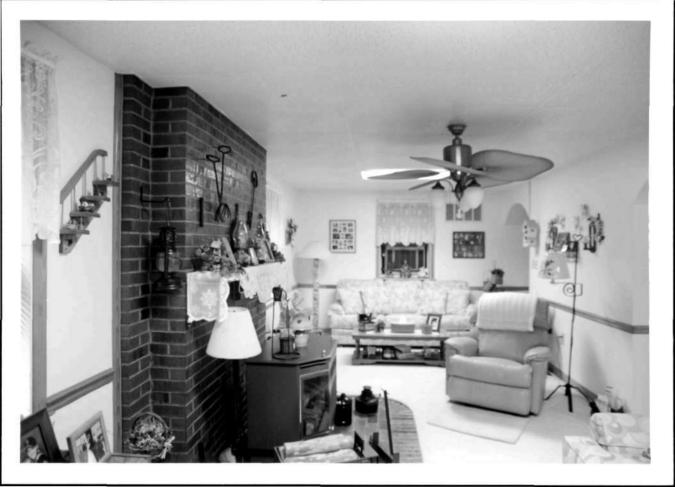
1 MIHP# F-1-009 A CASTLE HEIRS HOUSE FREDERICK COUNTY MD # Phillip W. Neuberg, Photographer 7 Photo token - 13 September 2006 a Location of Negative: MD (HPD 4 NTERIOR - VIEW OF 1ST FLOOR LIVING ROOM (WEST CHAMBER, ORIGINAL STRUCTURE) LOCKING NORTH #7

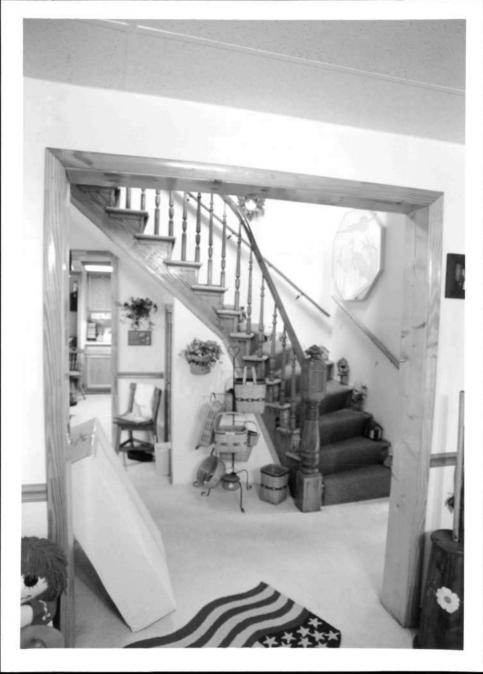
ANHIP # F-1-0009 D CASTLE HEIRS HOUSE FFREDERICK COUNTY, MD # Phillip W. Neuberg, Photographer # Photo Taken: 13 September 2006 # Location of Megitive: MD SHPO A INTERIOR VIEW - OF STAIRCASE TO ZNO FLOOK, FROM DINING ROOM CEAST CHAMBER, ORIGINAL STRUCTURE) LOOKING NORTH #9

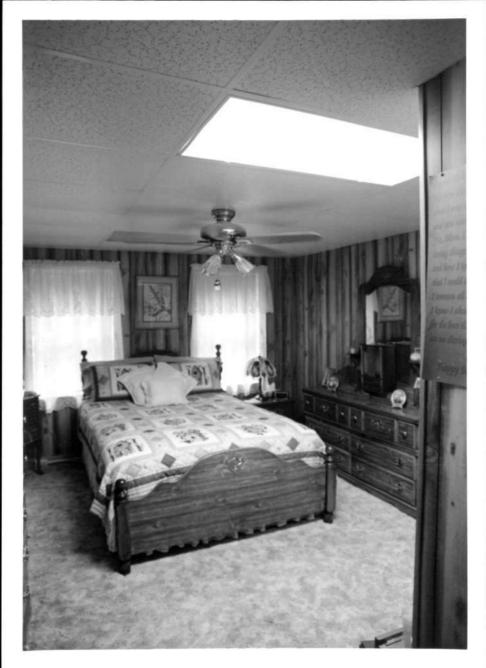
0MH119# F.1-009 CASTLE HEIRS HOUSE 4 FREDERICK COUNTY, MD a Phillip W. Neuberg, Photographer a Photo Token: 13 September 2006 A LOCATION of NEgOtive: MP SHO # INTERIOR VIEW - ZNO FLOOR, SOUTHEAST BEDROOM, LOOKING SOUTH

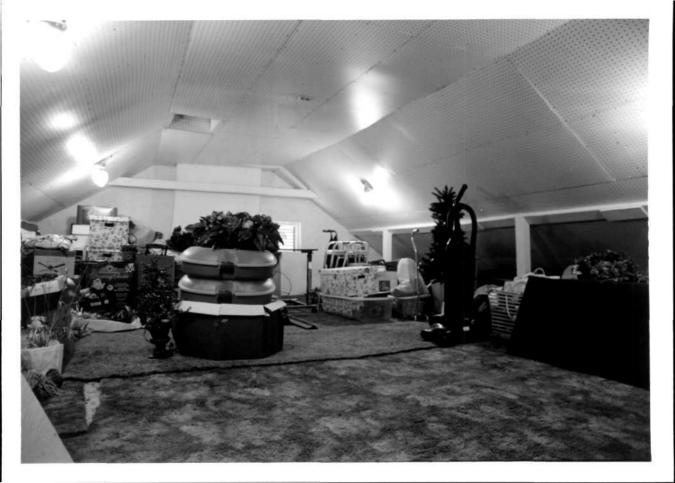
0 MH/P # F-1.009 · CASTLE HEIRS HOUSE # FREDERICK COUNTY, MD 4 Phillip W. Neuberg, Photographer # Photo Taken: 13 September 2006 a Location of Negative: MD5/4PD A INTERIOR VIEW. ATTIC, LOOKING EAST

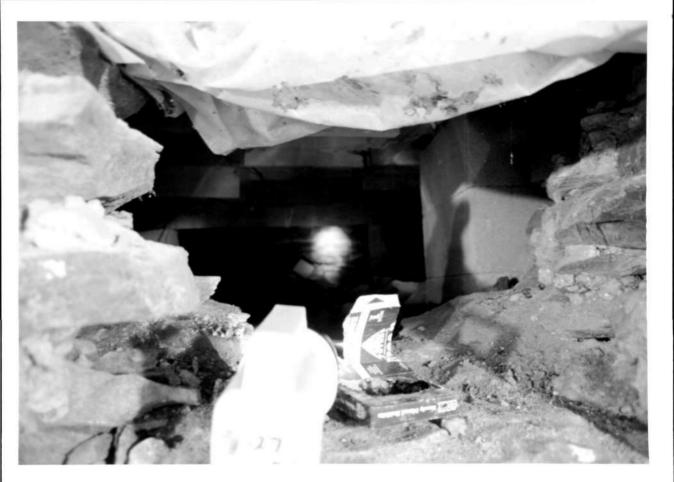
PM/HP# F-1009 WCASTLE HEIRS HOUSE # FREDERICK COUNTY, MD #Phillip W. Neuberg, hotographer # Photo taken 13 September 2006 # Location of Negative: MD SHPO I INTERIOR - VIEW of GROW Space Looking West

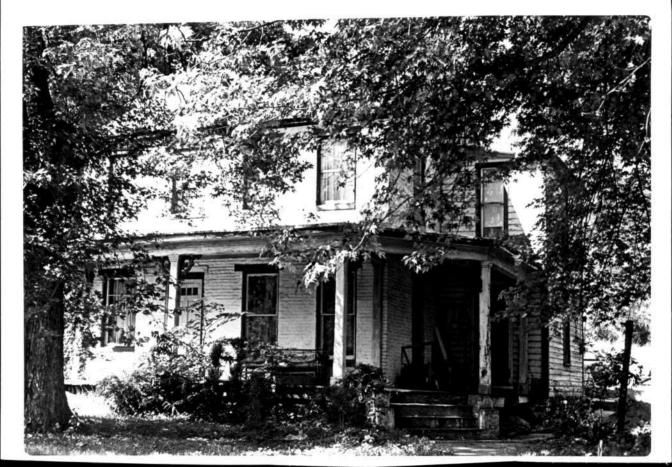
WEST EVENATION CEN 5/18

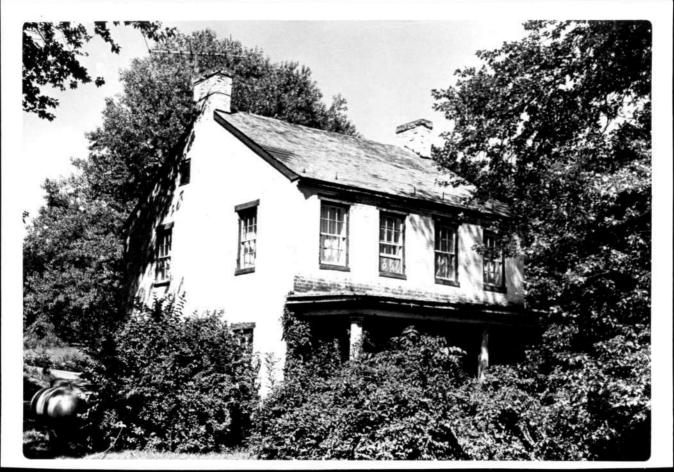
WEST ELEVATION CEW/ 5/78
